**NATIONAL REGISTER OF HISTORIC PLACES
REGISTRATION FORM**

BARLOW BUILDING

211 West Holly Street

BARLOW BUILDING
WHATCOM COUNTY, WASHINGTON

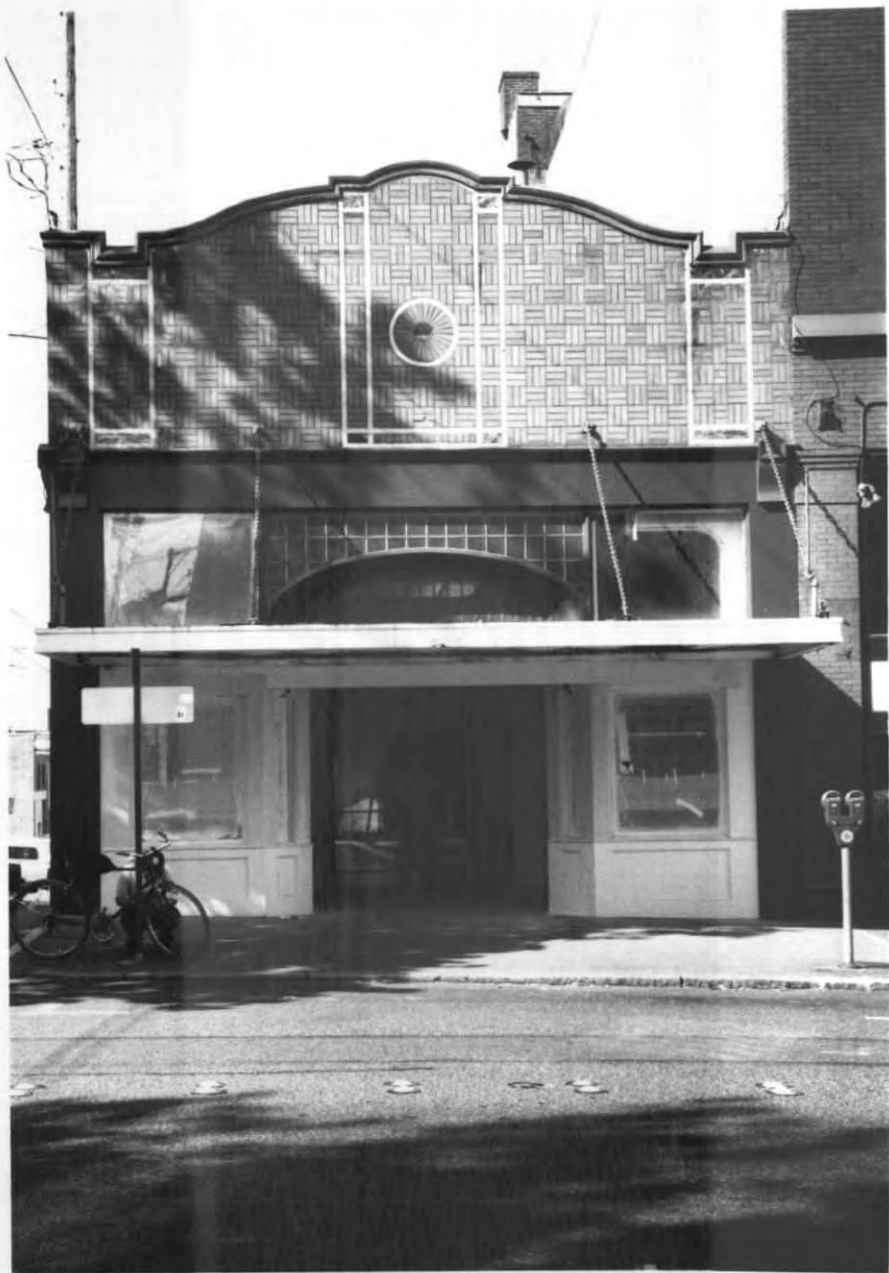
BARLOW BUILDING
211 W HOLLY ST
BELLINGHAM, WHATCOM, WA
DAVID JOHNSTON
MAY 2004
NORTHEAST FRONT FACADE
NO. 2 of 2 (SET 1)

The storefront consists of two broad display windows flanking a recessed, arched central entrance. A broad transom spans the entire storefront. This configuration of display window and transom wraps onto the east end of the southeast facade. Poured concrete piers clad in contemporary finishes flank the storefront. These piers carry the upper facade and broad lintel spanning the storefront. Small consoles with pedimented caps accent the corners above the storefront. Display windows set in wood frames feature a low, wood bulkhead and display counter on the interior. The transom above the display windows is divided into three principal bays. Each bay consists of multiple small leaded panes. The panes in the central bay taper above the recessed entrance to accommodate the arch spanning the entrance. A marble-surfaced ramp leads into the building from the sidewalk. A metal frame marquee spans the storefront and shelters the sidewalk and display windows. The condition of the storefront in 2004 is good. The storefront retains its character-defining form, function and detailing. Deteriorated framing and trim elements were repaired in-kind. Existing fabric supplemented by 1926 photographs guided the restoration of the storefront.

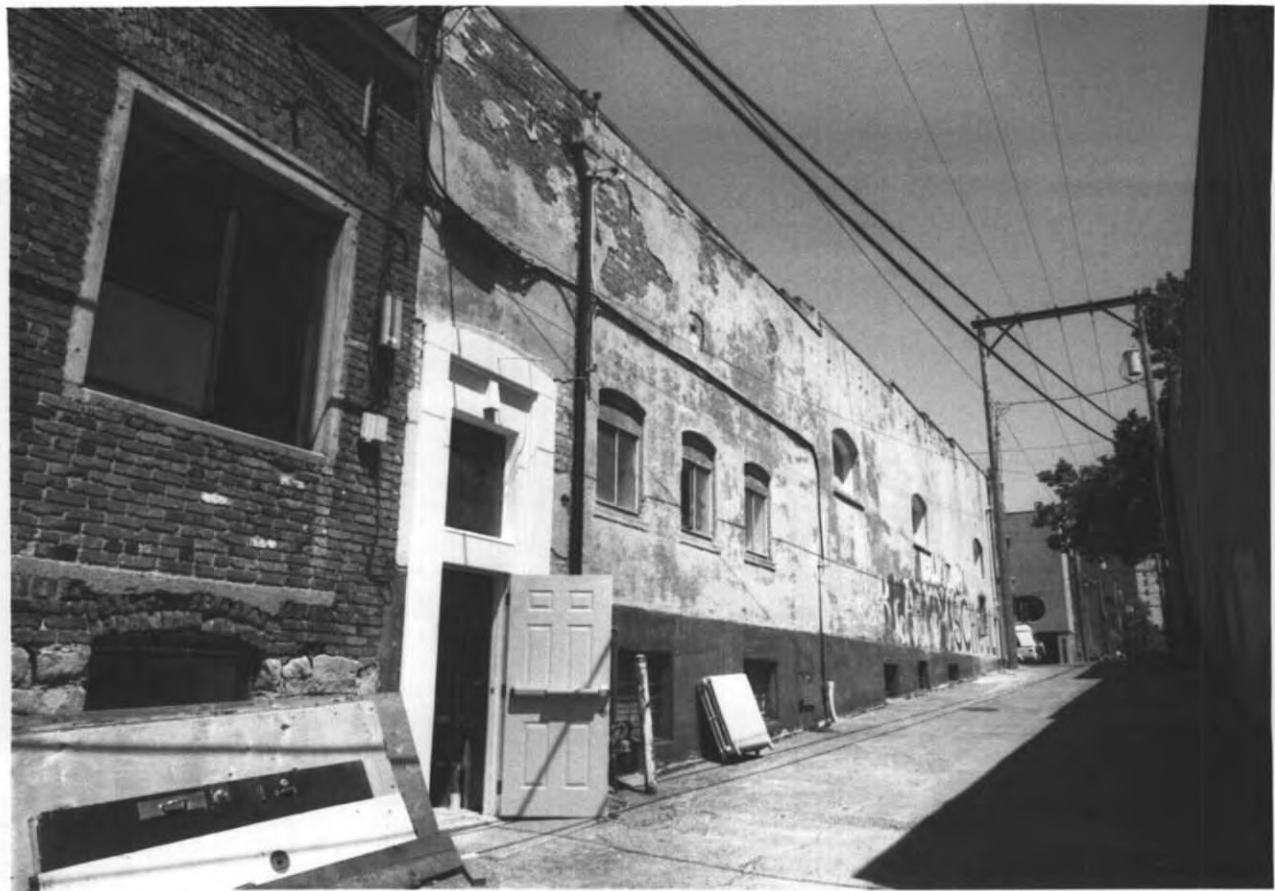
BARLOW BUILDING
211 W HOLLY ST
BELLINGHAM, WHATCOM, WA
DAVID JOHNSTON
JUNE 2004
SOUTHEAST SIDE FACADE
NO. 1 OF 5 (SET 2)

Windows punctuate only the secondary southeast facade. They consist of four basement windows, and contemporary windows into both the basement and first story. The building features five rectangular basement and six arched first story window openings. Wood sash basement windows consist of multiple vertical panes. The two on the south end feature four panes each; the two on the east end feature three and four panes each. The fifth, middle window consists of a contemporary, metal, horizontal-slider type window. All feature painted wood sills and frames. The southernmost window openings feature horizontal metal security bars set into the wood frames within the openings. First-story windows consist of three arched, hopper type, two-pane windows on the east end. Sash chains control the opening widths. Three aluminum sash, horizontal-slider type windows with blind arches above punctuate the south end of the facade. Plywood in-fill within the window openings accommodates the smaller window size. All feature painted wood frames. Windows on the south end feature painted stucco-clad row-lock brick sills. Windows on the east end feature painted stucco-clad sills. The condition of the windows in 2004 is poor. As of 1913 prior to the southwest addition, two windows punctuated the southeast facade with a single window on the southwest facade. Following the southwest addition, only the southeast facade featured windows. By 1930, the number of windows on the southeast facade increased to four. Basement level windows exhibit extensive paint and moderate material deterioration.

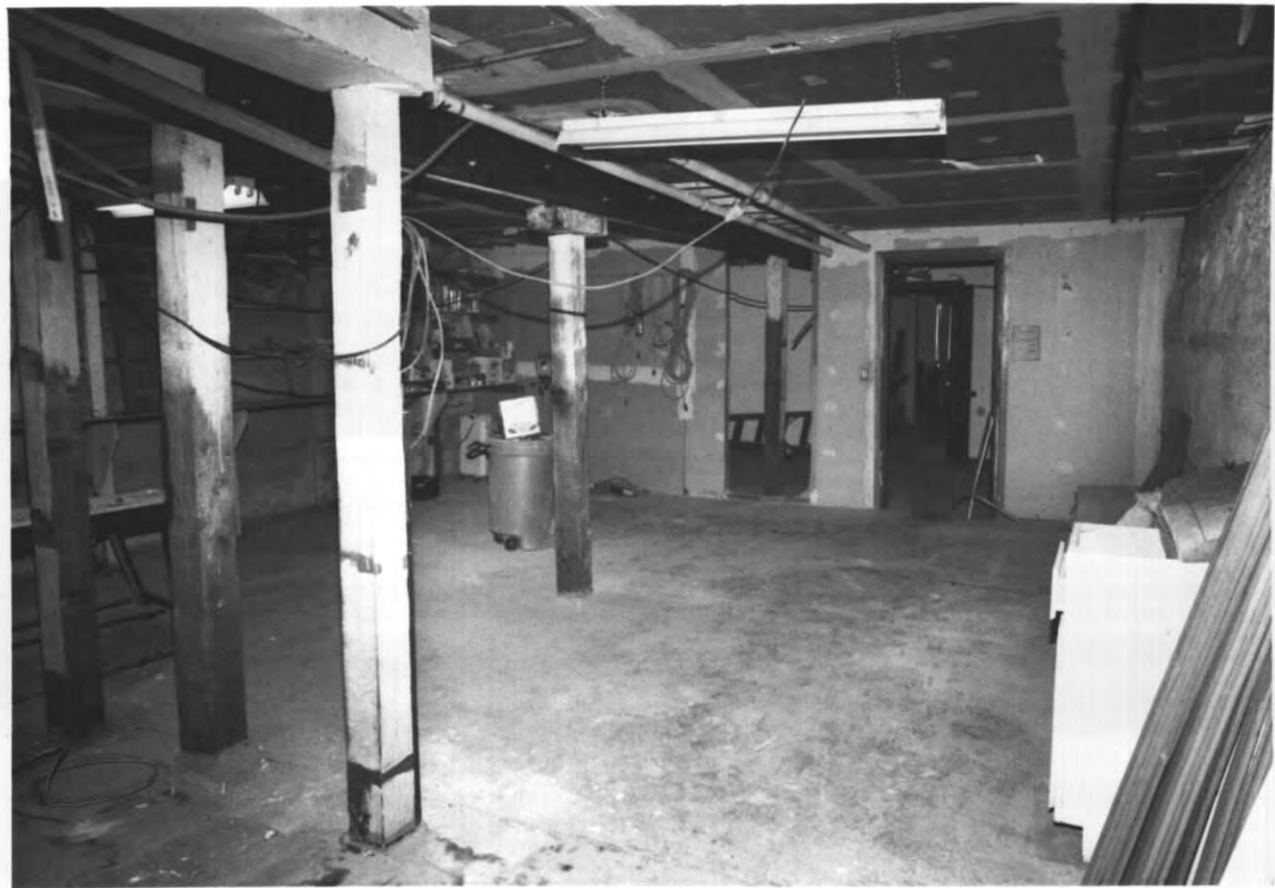
BARLOW BUILDING
211 W HOLLY ST
BELLINGHAM, WHATCOM, WA
DAVID JOHNSTON
JUNE 2004
BASEMENT, LOOKING NORTH
NO. 7 of 7 (SET 2)

The basement features two main volumes. Exposed concrete walls line the perimeter. Wood posts along a central axis carry floor joists. Sheet rock covers the ceiling. The basement features a concrete slab at grade. Contemporary wood frame partitions subdivide the southwest end. Built-in, contemporary kitchen cabinets stem from the space's recent function as a rental unit. The condition of the basement in 2004 is fair to poor. The basement historically provided utilitarian storage space for the leather goods store. The basement retains its overall form.
