National Register of Historic Places
Inventory—Nomination Form

historic Bellingham National Bank Building

street & number 101-111 East Holly Street not for publication

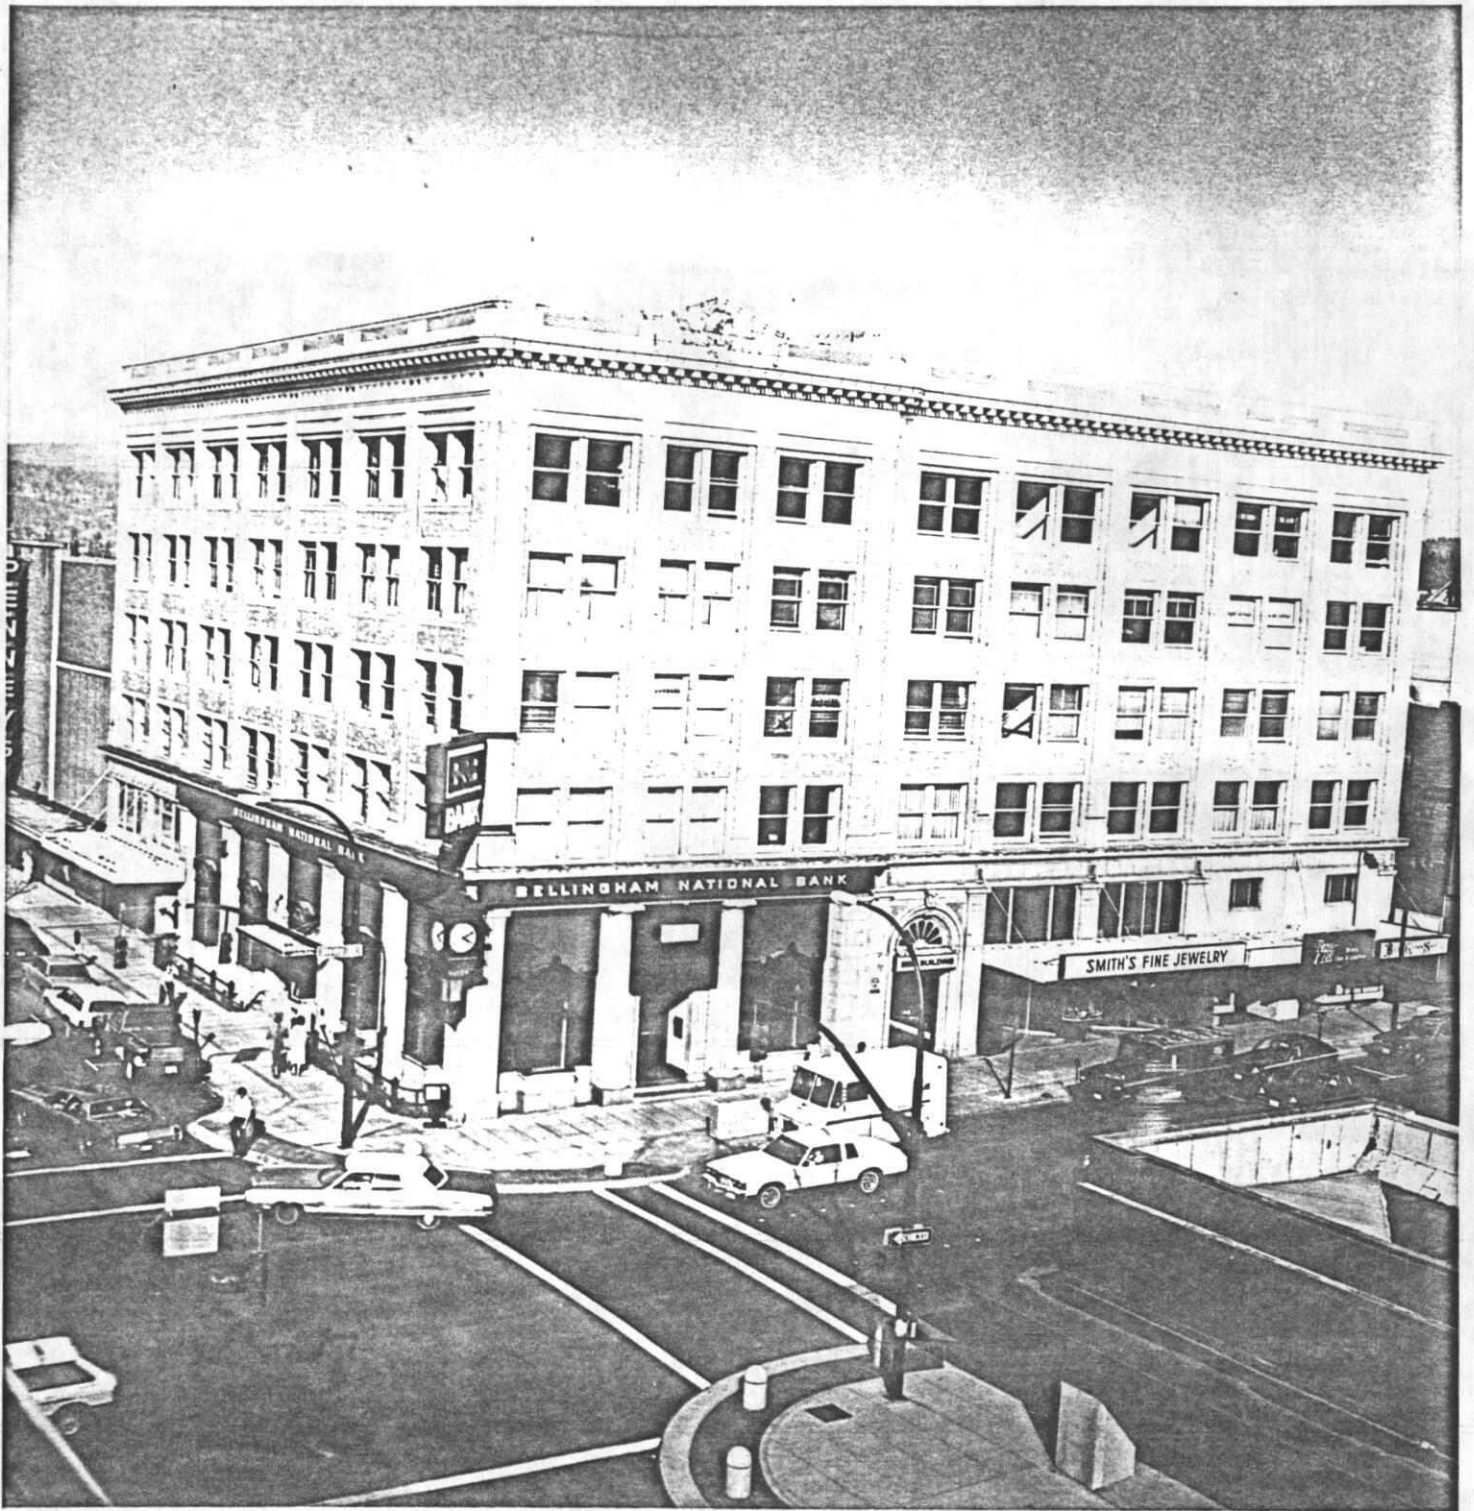
1 of 4

Northwest and southwest facades, facing
east

The ground floor and basement of the structure are rectangular in plan measuring 125 feet along the Holly Street (southwest) elevation and 105 feet along the Cornwall Avenue (northwest) elevation. The upper four floors then rise in a fifty foot deep "L" plan along the streetfront elevations. Decorative features are limited to the elevations on the northwest and southwest sides. The other facades have exposed concrete walls.

There is a cornice with frieze between the first and second floors of the southwest and northwest facades. These have been partially covered with a new bank sign. Above the cornice are office windows that are paired and regularly placed across the street and rear facades. Separating the windows are piers that project slightly from the wall plane. The windows are separated vertically by simple spandrels. Both pilasters and spandrels are clad in glazed yellow brick.

The office floors are terminated by a prominent entablature of white terra cotta. Details include large modillions, a low parapet wall above the cornice and an ornamental pediment with an eagle in the tympanum. These classically derived details were commonly applied to commercial style structures. They present an interesting counterpoint to the rather simple office floors below.
